8x930Ax (8x930AD, 8x930AE) SPECIFICATION UPDATE

Release Date: February 1999

Order Number: 272940-017

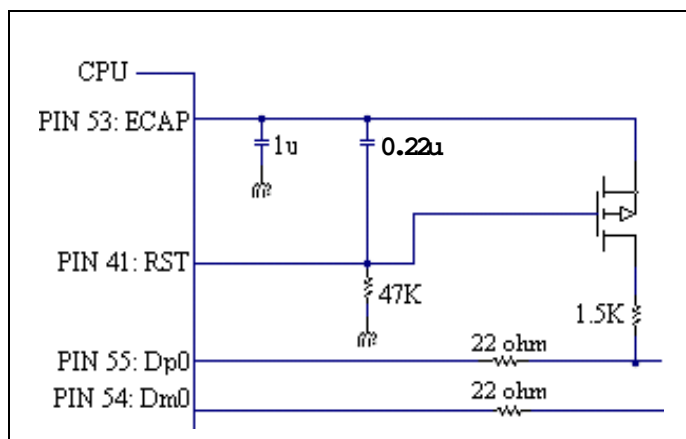
Figure 3. Delay Circuitry

PROBLEM: The problem was first seen when a USB peripheral using the Intel® 8x930 chip was plugged into the USB port of some Toshiba laptops failed to enumerate correctly during a cold boot sequence. The root cause can be tied to the system determining device speed too quickly by misinterpreting power-on transients on the Dm0 line as an indication that the device was low speed when it was really high speed. Some systems may not exhibit this behavior if they power on the USB bus prior to OS initialization thus effectively "hiding" the power-on transients from the host controller/driver. Also, systems that have a host controller/driver that is designed to wait a long enough period of time following power-up prior to device speed determination will not experience this problem (such as systems using the Intel® PIIX4). The problem has been seen on the Toshiba* 500 series and 300 series notebooks (which use a non-Intel host controller) running Microsoft* Windows95/98* with Microsoft* supplied OHCI host controller drivers. The Toshiba* Tecra780* uses the Intel® PIIX4 host controller and does not exhibit this problem. The failure mode at Dp0/Dm0 can be identified by observing a low-speed J at a full-speed device following initial USB reset. Please see the latest USB specification for bus state definitions.

IMPLICATION: USB peripherals using the Intel® 8x930 that are plugged into a system where USB bus power is turned on after OS/host controller initialization (and the system's host controller/host controller driver does not wait long enough prior to speed determination) will not enumerate during a cold boot sequence. Although this problem has only been observed with a full-speed peripheral using the 8x930Ax, it could also occur with other peripherals including low speed peripherals using the 8x930Ax.

The power up transients do not cause failure during a hot attach (attach to a powered port) because the power lines make physical contact before the signal lines (Dm0/Dp0 connectors are 1mm shorter than 5V and GND). The time between the two contacts allows the transients to die down before the system evaluates the speed. Similarly for devices plugged in prior to cold boot, host controllers/drivers should be designed to wait a specified period of time before attempting to evaluate speed to allow for power-on stabilization; please see the latest USB specification for details.

WORKAROUND: (design impact) Insert a MOSFET on the Dp0 line delaying the energizing of the pull-up resistor by about 8mS. The circuit inserts a 5 to 8 millisecond delay in powering Dp0 thus eliminating the SE1 caused by power-on transients during the power-on reset of the 8x930. See Figure 3 for details.

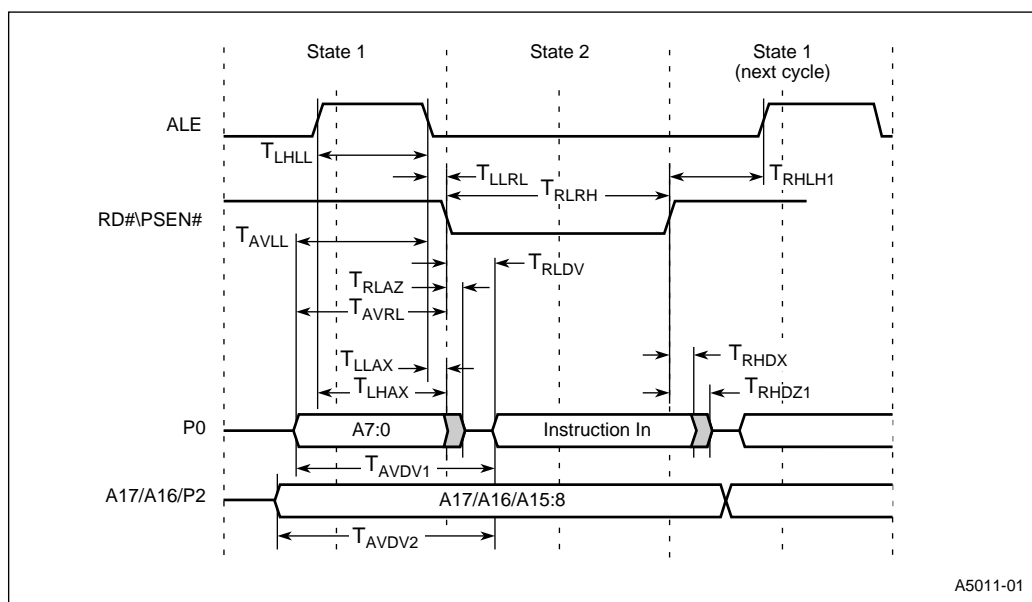
Figure 4. External Code Fetch, Nonpage Mode

PROBLEM: The T_{RHDZ1} (Instruction Float After RD#/PSEN# High) specification on the 8x930Ax when operating at 12 MHz is 10 ns. However, a slow memory device such as an EPROM typically takes approximately 30 – 90 ns to float its output. (This specification, generically called T_{PHZ} , may vary depending on the memory type and manufacturer.) Figure 4 and Figure 5 illustrate the T_{RHDZ1} timing.

The difference between the T_{RHDZ1} and T_{PHZ} specifications causes contention on the data bus (P0 in nonpage page, P2 in page mode). The 8X930Ax begins to drive the address for the next bus cycle while the memory device is still driving data from the previous bus cycle.

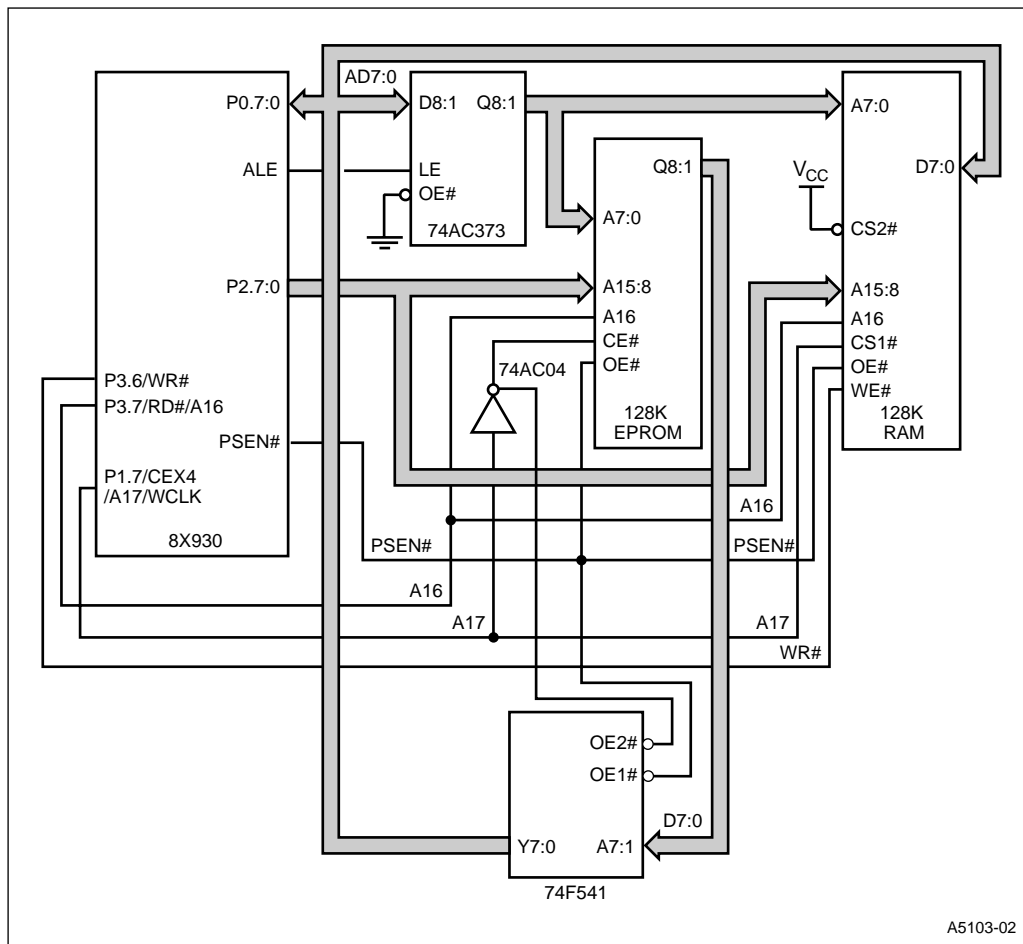
Figure 6. Example Bus Contention Solution for 8X930Ax (Nonpage Mode)

When PSEN# goes high after a read, OE1# and OE2# are deasserted, and the buffer's output switches to the high-impedance state in approximately 9.5 ns (T_{PHZ} for a typical 74F541; the value may vary from one manufacturer to another). Thus, contention on the data bus is prevented. This or a similar hardware solution is recommended for 8X930Ax designs in which memory devices do not meet the T_{RHDZ1} timing specification.

To prevent this contention, designers can use a buffer to isolate the output of the memory device from the data bus (port 0 or port 2) of the 8x930Ax. This will prevent the memory device from driving the data bus during the critical period after T_{RHDZ1} expires. We suggest a buffer such as the 74F541 octal, three-state line driver shown in Figure 6.

Figure 6 illustrates the connections of an 8X930Ax configured for nonpage mode with EPROM and RAM in external memory. If your system uses a different configuration, your circuit will be different from the example. The 74F541 is enabled to pass data from the EPROM to the 8X930Ax (port 0) when OE1# and OE2# are active. Table is a truth table for the 74F541.
